Document Type: Service invoice
Subject: "HL PORT WALCOTT" BWT filter repair

Service Report

SUBJECT		" HL PORT WALCOTT" BWT filter repair type : 6.18.3 1100. 700 , Fabr : 4029626 / 2A , 2B									
VESSEL NAME		HL PORT WALCOTT				HULL NO.					
MAKER		Boll+Kirch Filterbau GmbH				ORDER NO.					
ENGINEER		Wonje Lee /				LOCATION		Posco Pohang		237 km	
TIME SHEET		WORK TIME		PER	TOTAL HOURS	TRAVELLING / WAITING HOURS	Other	NORMAL HOURS (09:00~18:00)	OT-A (06:00~09:00) (18:00~22:00)	OT-B (22:00~06:00) / Sat, Sun & National holiday OT-C (06:00~22:00)	Non-working days OT-D (22:00~06:00)
DATE	DAY	BEGIN	END								
2018-06-01	Fri	11:00	~ 19:00	1	8.00	5.00		3.00			
2018-06-02	Sat	8:00	~ 20:00	1	12.00	3.00	1.00			8.00	
				2	20.00	8.00	1.00	3.00	-	8.00	-
TIME SCHEDULE		WORK REPORT									
2018-06-01

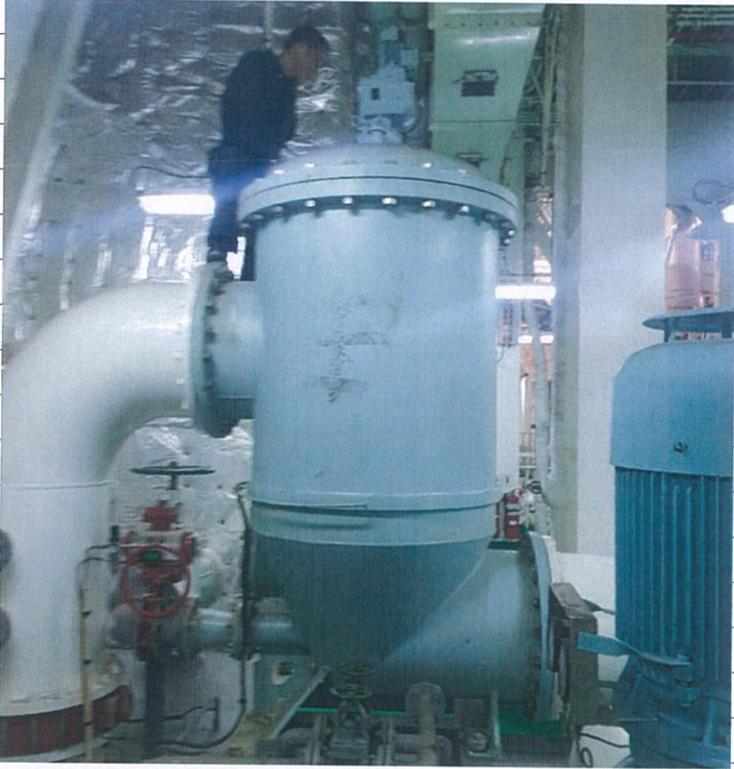
A large, vertical, blue industrial pump or filter unit is shown in a confined space. A worker in dark clothing is perched on top of the unit, possibly performing maintenance or inspection. The unit has a large white pipe on the left and a blue motor on the right. The background shows insulation and other equipment.

- dismantled the filter cover for NO. 1									
		- lifted up the element housing and replaced the part , bushing, spring, plate , longer bolts with new one

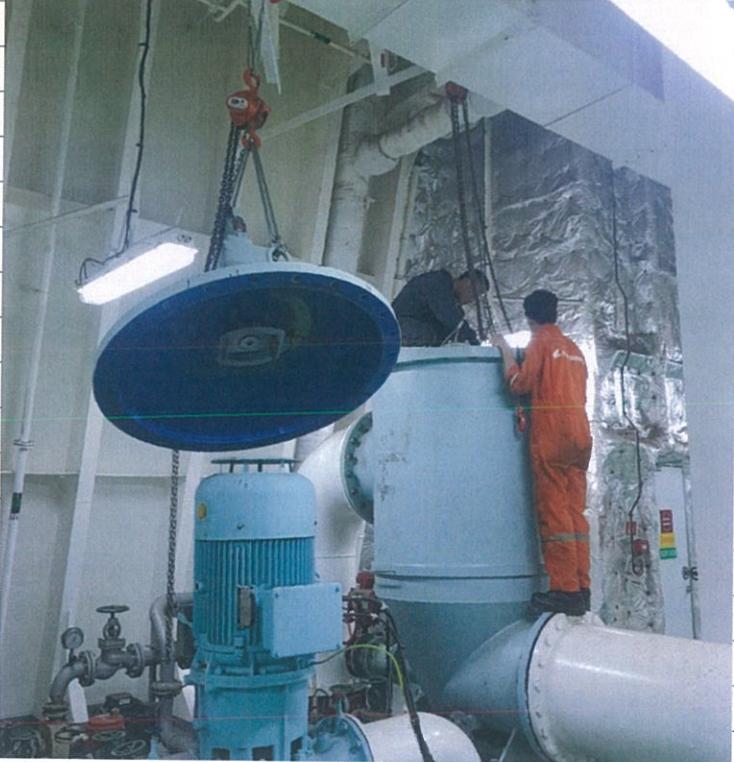
A large, blue industrial pump is being lifted by a crane. The pump is suspended by chains and a hook. A worker in an orange jumpsuit is standing next to the pump, likely guiding it. The pump is positioned above a blue motor. The background shows insulation and other equipment.

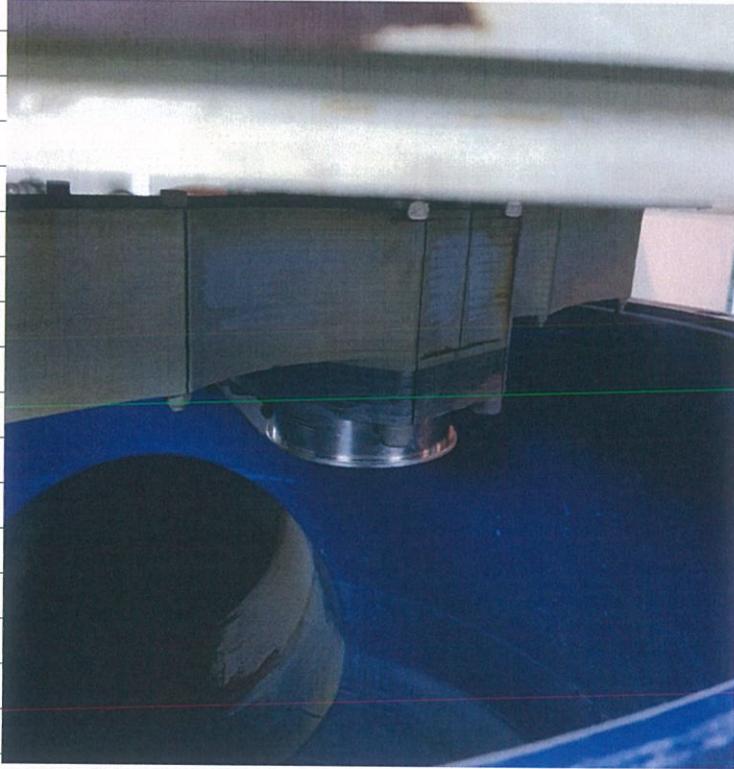
<p>A close-up view of the filter unit's base as it is lowered into the blue container. The unit is suspended by a chain and hoist. The blue container is visible in the foreground.</p>

- dismantled the filter cover for NO. 2									
		- lifted up the element housing and replaced the part , bushing, spring, plate , longer bolts with new one
