# Service Report

TIME SCHEDULE	WORK REPORT
	<p>1) No. 1 filter</p>

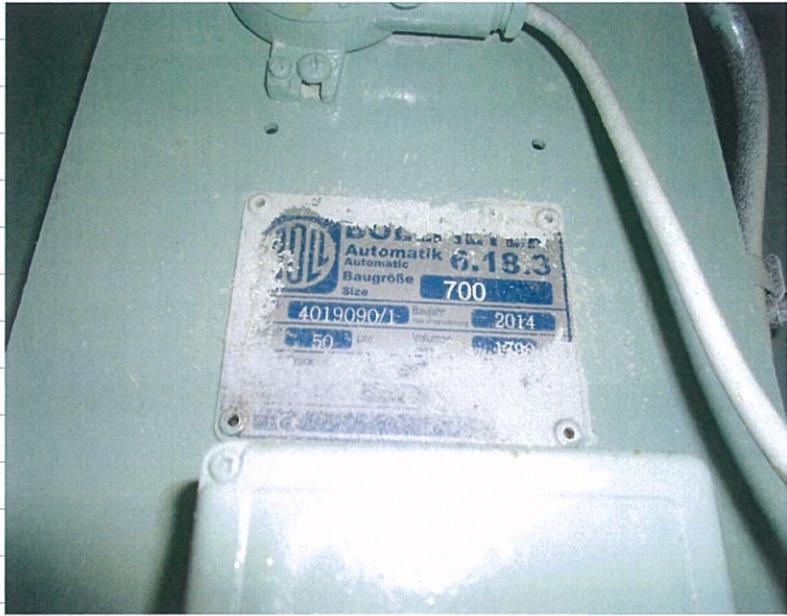
<p>The image shows a close-up of a rectangular metal label mounted on a light green surface. The label contains the following text: 'BOLLFILTER' logo, 'Automatic 6.18.3', 'Baugröße 700', '4019090/1', '2014', '50', and 'Volume'. There are also some smaller, less legible markings.</p>

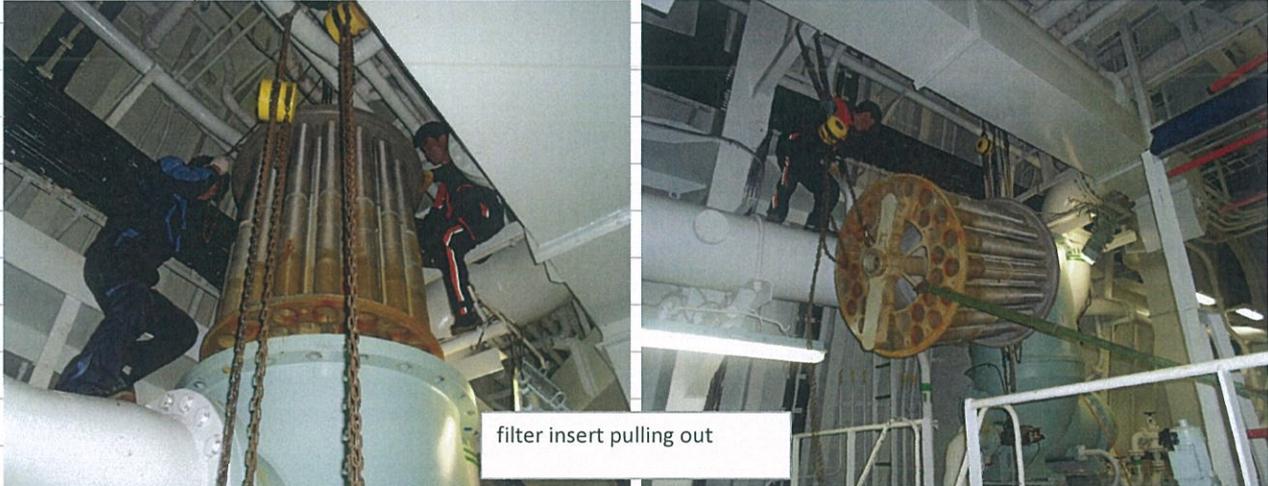
<p>The left photograph shows two workers in dark clothing and safety gear standing on a platform, pulling a large, vertical, cylindrical metal filter insert. The right photograph shows a similar scene from a different angle, with the filter insert being hoisted by a chain and pulley system.</p> <p>filter insert pulling out</p>

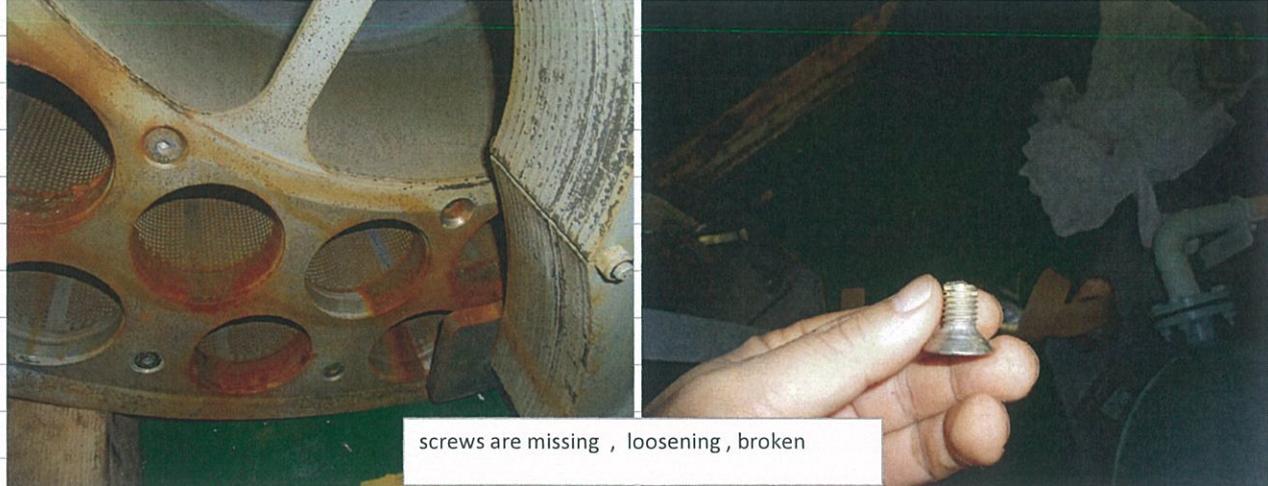
<p>The left photograph is a close-up of the filter insert's internal structure, showing several circular mesh screens and a metal frame. The right photograph shows a hand holding a small, cylindrical metal screw or bolt.</p> <p>screws are missing , loosening , broken</p>

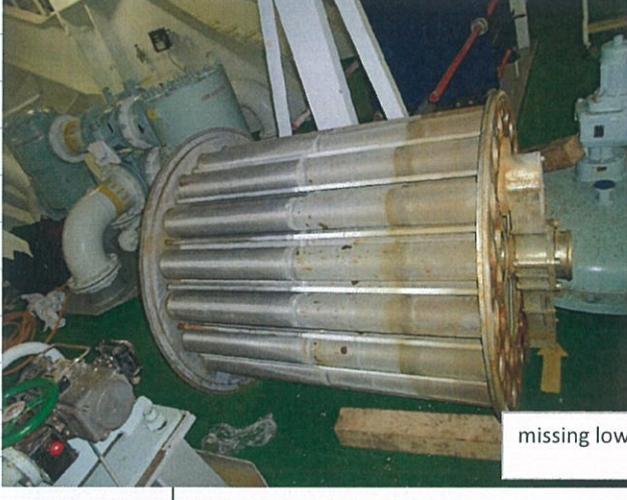
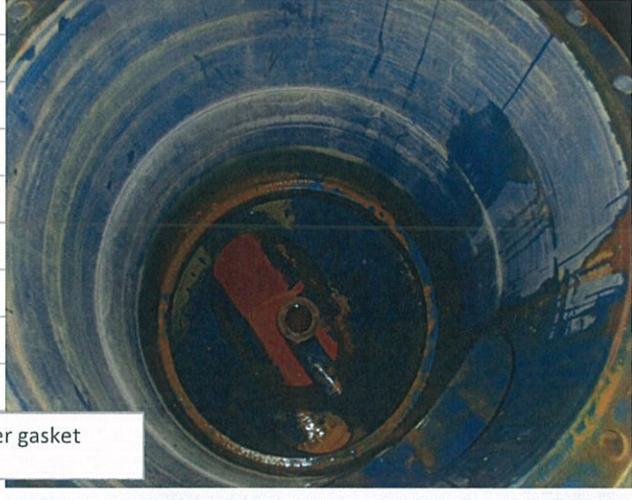
<p data-bbox="703 1294 979 1355">missing lower gasket</p>

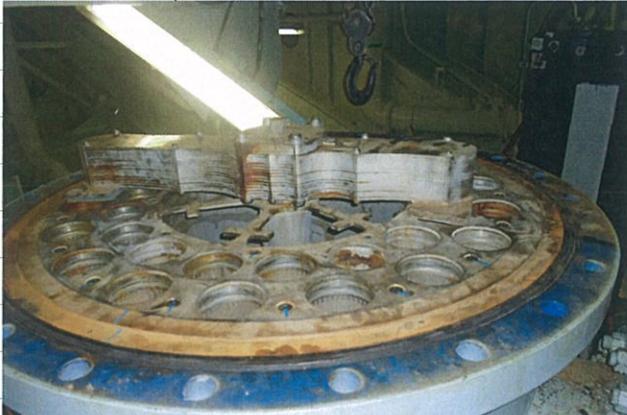
<p data-bbox="215 795 766 828">filter inserting in position. good hand turning of flushing</p>

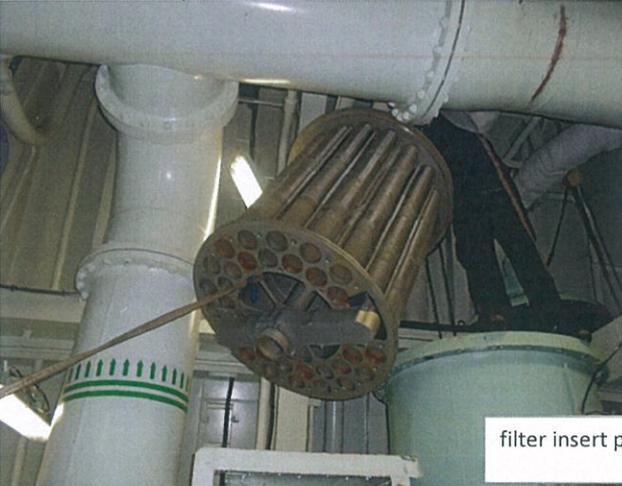
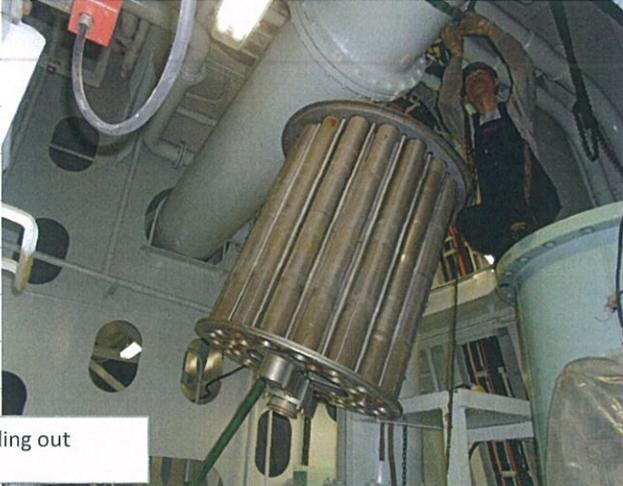
TIME SCHEDULE	WORK REPORT
	<p>2 ) No. 2 filter</p>

<p>filter insert pulling out</p>
